4. TITLE (and Subtitle) MOISTURE DETECTION IN ROOFS WITH CELLULAR PLASTIC INSULATION—WEST POINT, NEW YORK, AND MANCHESTER, NEW HAMPSHIRE	5. TYPE OF REPORT & PERIOD COVERED

The study was conducted under DA Project 4A762730AT42, Design, Construction and Operations Technology for Cold Regions, Task D, Cold Regions Design and Construction, Work Unit 015, Infrared Inspection of New Roofs Prior to Acceptance.

**MOISTURE DETECTION IN ROOFS WITH CELLULAR PLASTIC  
INSULATION - WEST POINT, NEW YORK, AND MANCHESTER, NEW HAMPSHIRE**

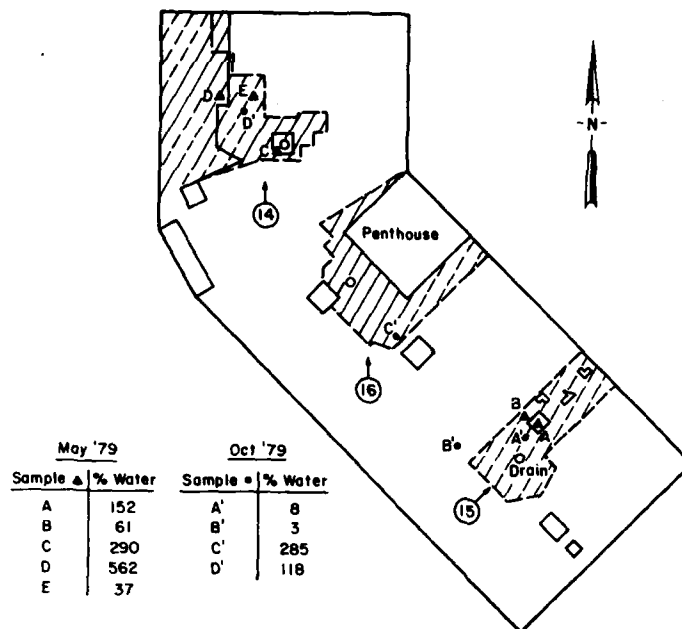
A plan view of this area (Fig. 17) shows two wet areas. Two thermograms and one photograph are shown in Figure 18 of the wet area bordering the southeast parapet. No appreciable change was detected in the shape or size of either wet area between the May and October surveys, suggesting that repairs to the counterflashings have been successful in preventing further wetting of this roof. Core samples indicate that little or no drying has taken place.

Figure 17. Plan view of Building 667A-east. Open hatching indicates areas of nonuniform brightness (mottling).

The roof on Building 667A-east had two areas of wet insulation. These areas along the southeast parapet wall and around the penthouse should be replaced under terms of the warranty.
